Checklist for Stormwater Report

TABLE 1: ORIGINAL, EXISTING & PROPOSED CONDITIONS - PEAK RUNOFF RATES & TOTAL RUNOFF VOLUMES
1089 Millbury Street - Worcester, Massachusetts

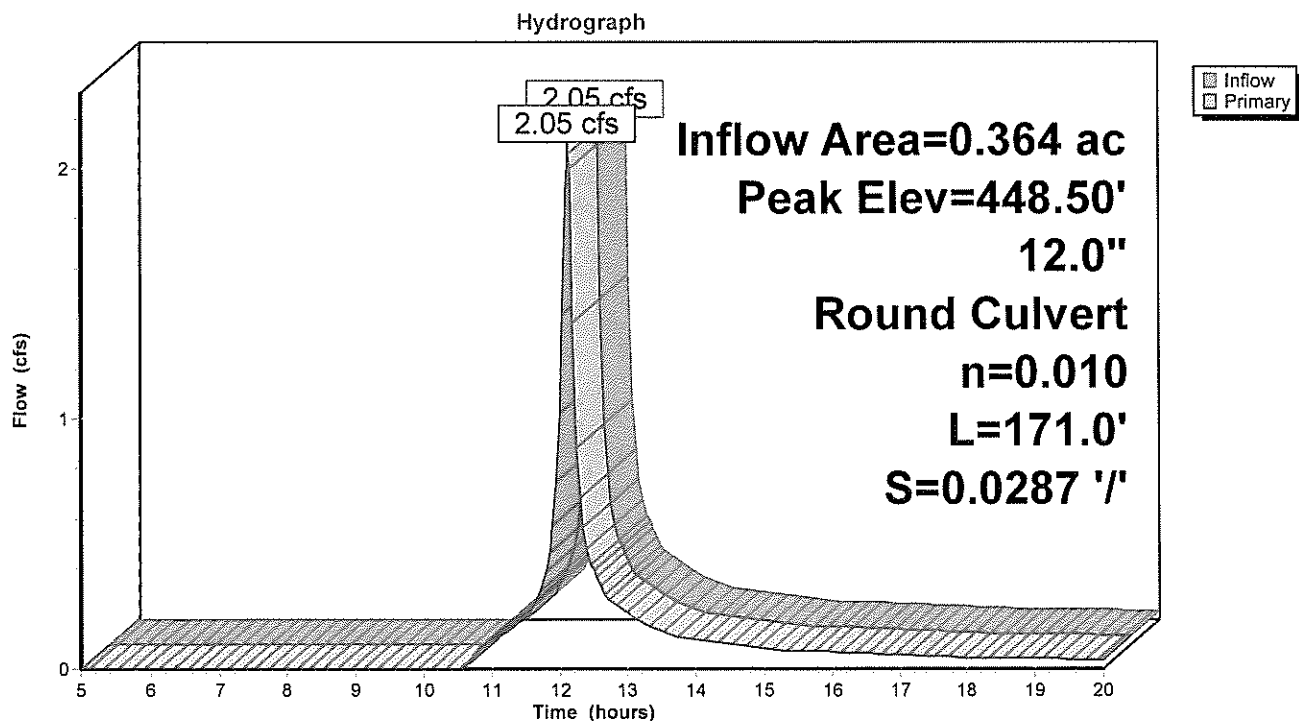
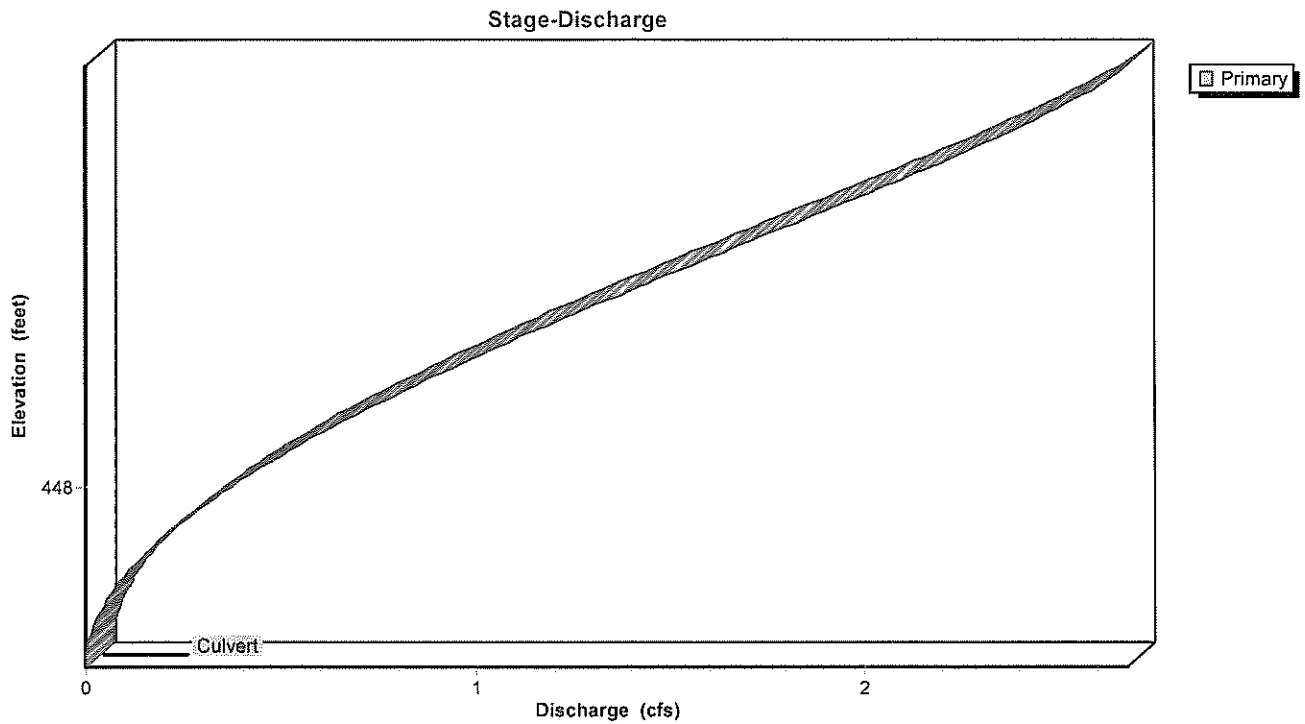
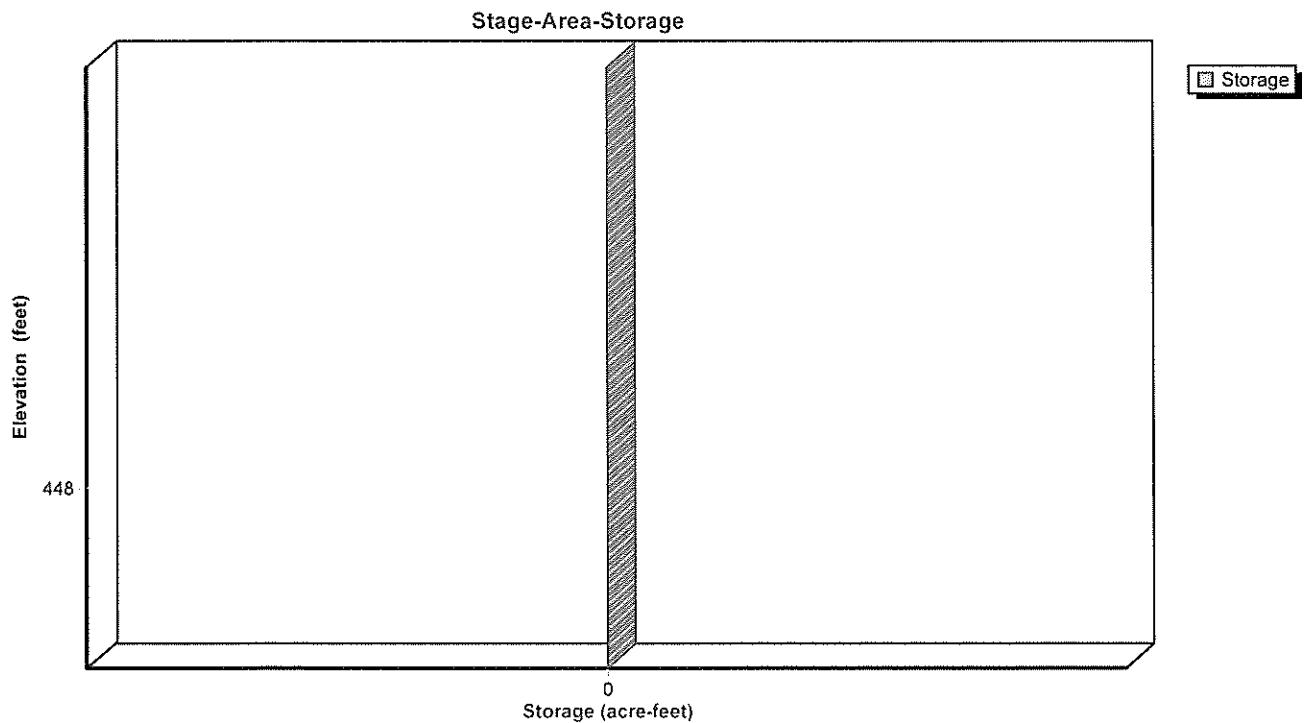
Summary for Pond CB2: Catch Basin

Inflow Area = 0.364 ac, 0.00% Impervious, Inflow Depth > 4.06" for 100-Year event
 Inflow = 2.05 cfs @ 12.13 hrs, Volume= 0.123 af
 Outflow = 2.05 cfs @ 12.13 hrs, Volume= 0.123 af, Atten= 0%, Lag= 0.0 min
 Primary = 2.05 cfs @ 12.13 hrs, Volume= 0.123 af
 Routed to Reach DL : 12" D PVC Drail Line to CB2 in Millbury Street & Municipal Sewer

Primary OutFlow Max=1.97 cfs @ 12.13 hrs HW=448.48' (Free Discharge)
 1=Culvert (Inlet Controls 1.97 cfs @ 3.00 fps)

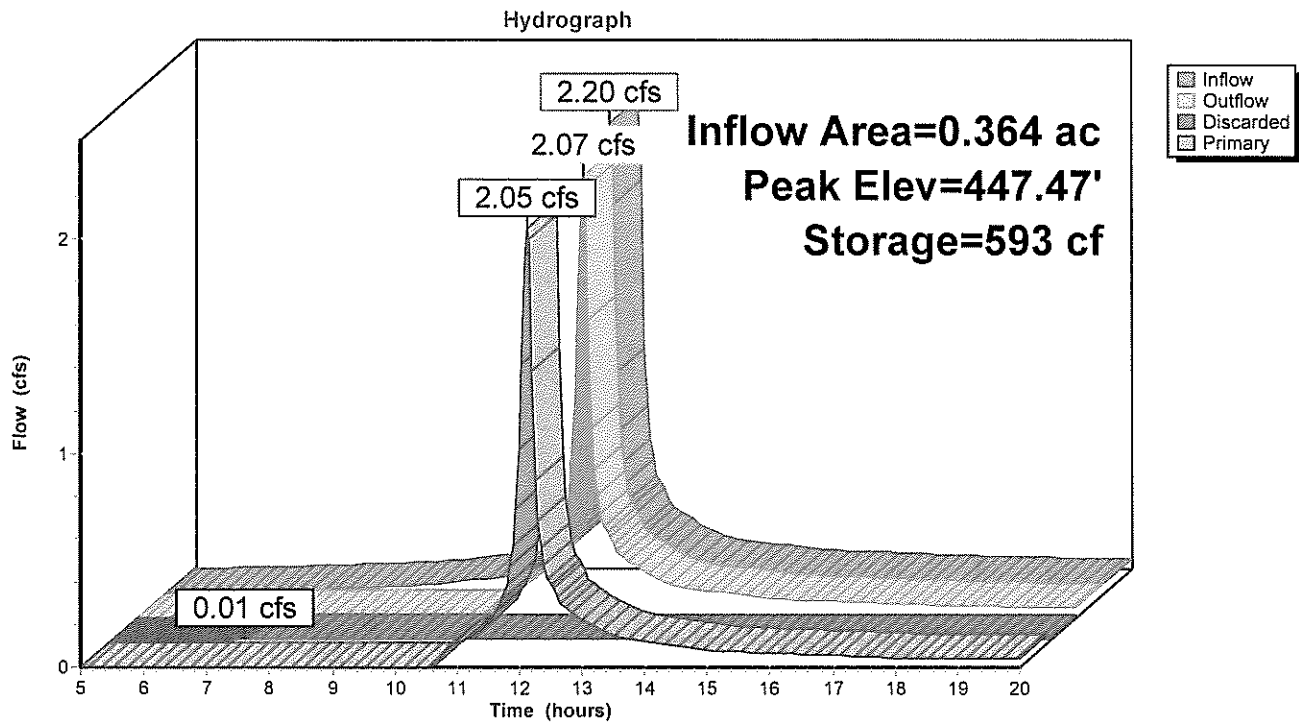
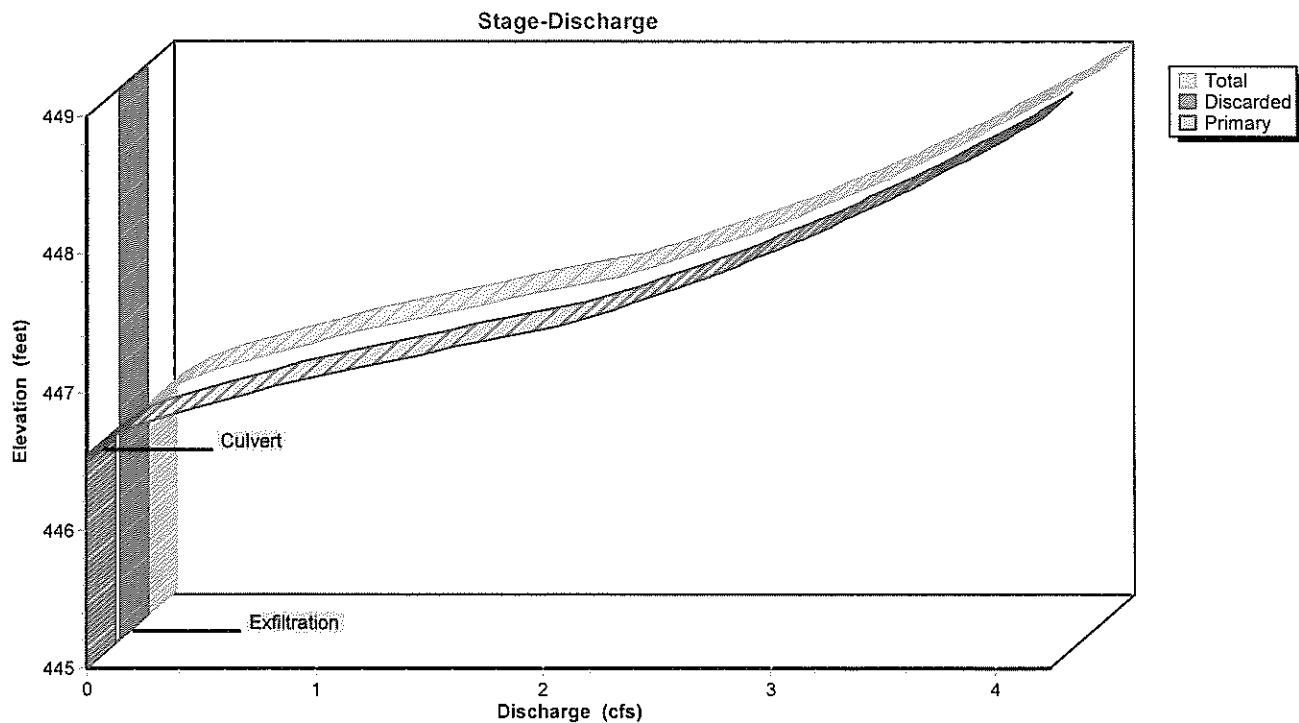
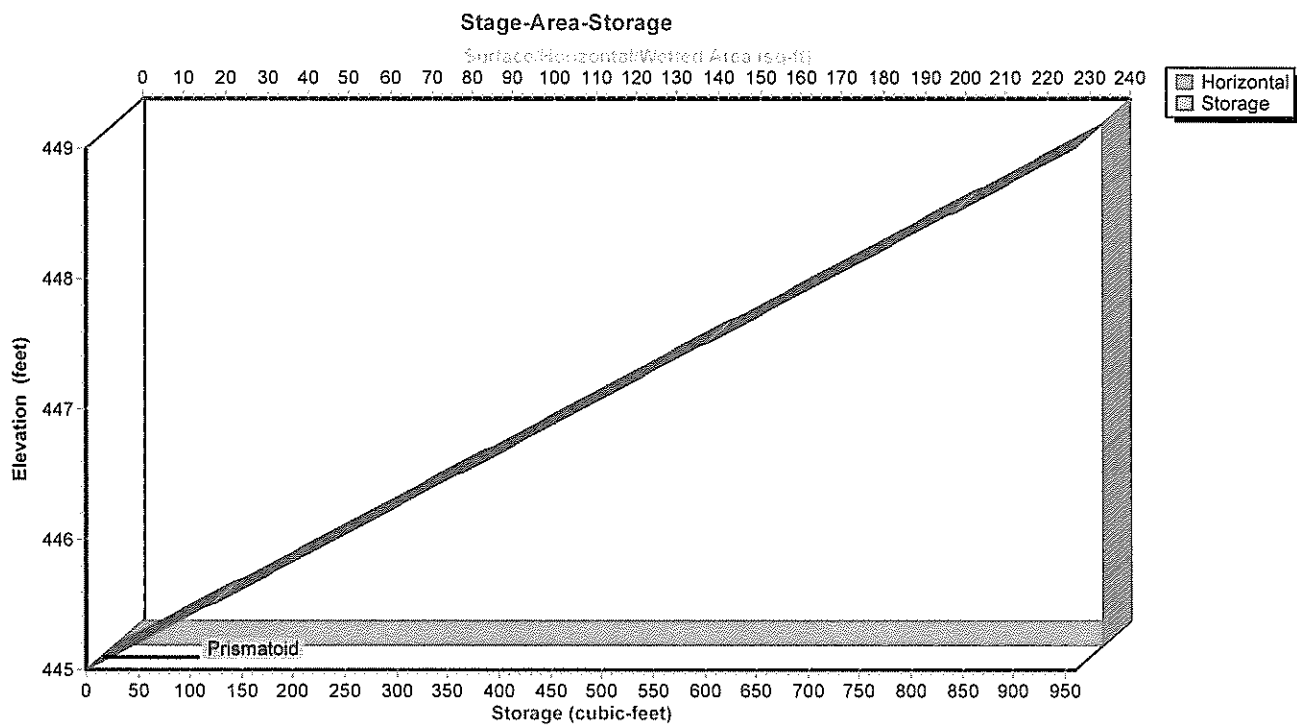
Summary for Pond IT: Interceptor?Recharge Trench

Inflow Area = 0.364 ac, 0.00% Impervious, Inflow Depth > 4.86" for 100-Year event
 Inflow = 2.20 cfs @ 12.10 hrs, Volume= 0.148 af
 Outflow = 2.07 cfs @ 12.13 hrs, Volume= 0.139 af, Atten= 6%, Lag= 1.5 min
 Discarded = 0.01 cfs @ 7.15 hrs, Volume= 0.015 af
 Primary = 2.05 cfs @ 12.13 hrs, Volume= 0.123 af
 Routed to Pond CB2 : Catch Basin

Primary OutFlow Max=1.97 cfs @ 12.13 hrs HW=447.44' (Free Discharge)
 2=Culvert (Barrel Controls 1.97 cfs @ 3.31 fps)

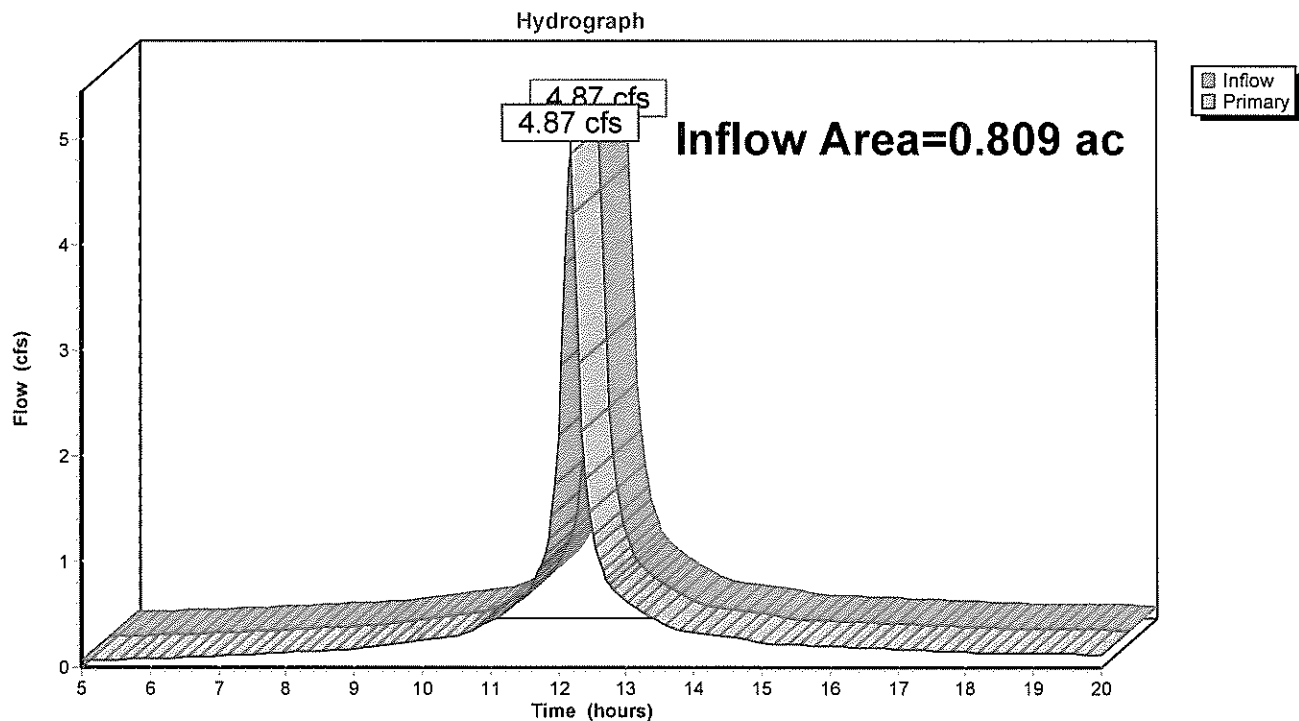
Summary for Link C-M.S.: Design Point - Current Conditions - Millbury Street

Inflow Area = 0.809 ac, 11.27% Impervious, Inflow Depth > 6.46" for 100-Year event
Inflow = 4.87 cfs @ 12.18 hrs, Volume= 0.436 af
Primary = 4.87 cfs @ 12.18 hrs, Volume= 0.436 af, Atten= 0%, Lag= 0.0 min

Primary outflow = Inflow, Time Span= 5.00-20.00 hrs, dt= 0.05 hrs

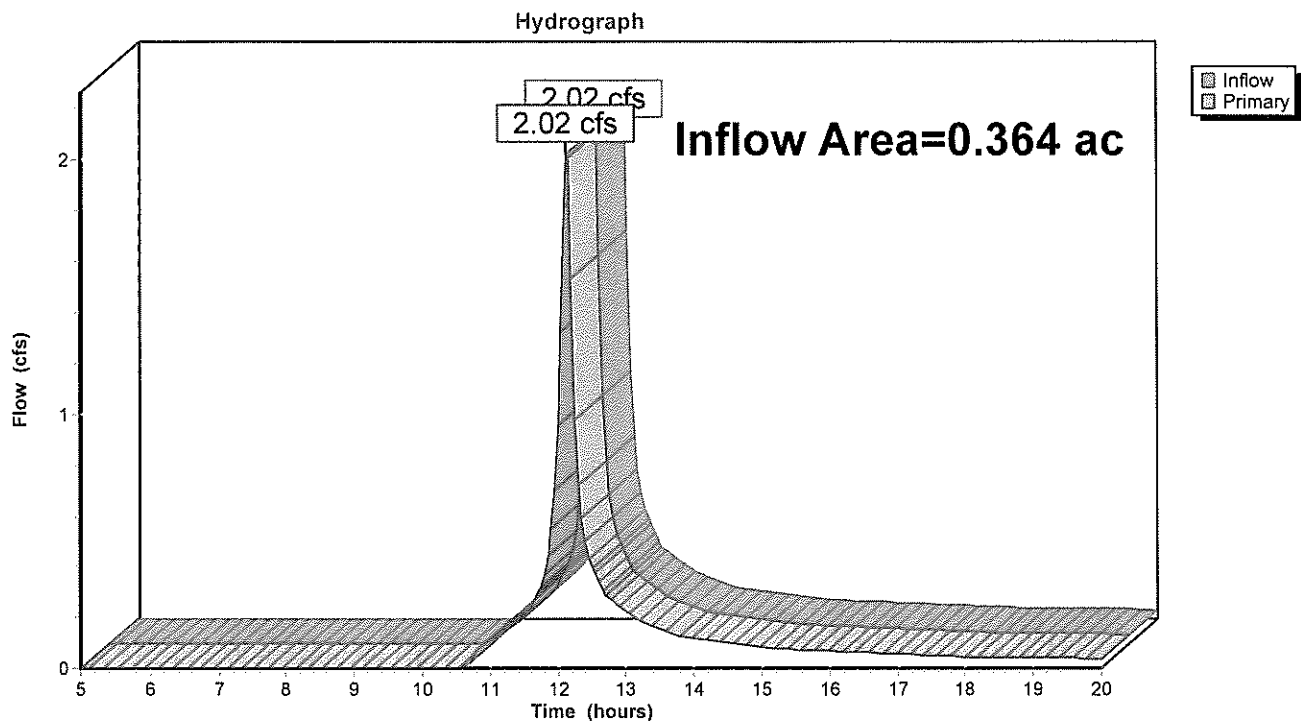
Summary for Link CB3: Design Point - Municipal Catch Basin in Millbury Street

Inflow Area = 0.364 ac, 0.00% Impervious, Inflow Depth > 4.06" for 100-Year event
Inflow = 2.02 cfs @ 12.14 hrs, Volume= 0.123 af
Primary = 2.02 cfs @ 12.14 hrs, Volume= 0.123 af, Atten= 0%, Lag= 0.0 min

Primary outflow = Inflow, Time Span= 5.00-20.00 hrs, dt= 0.05 hrs

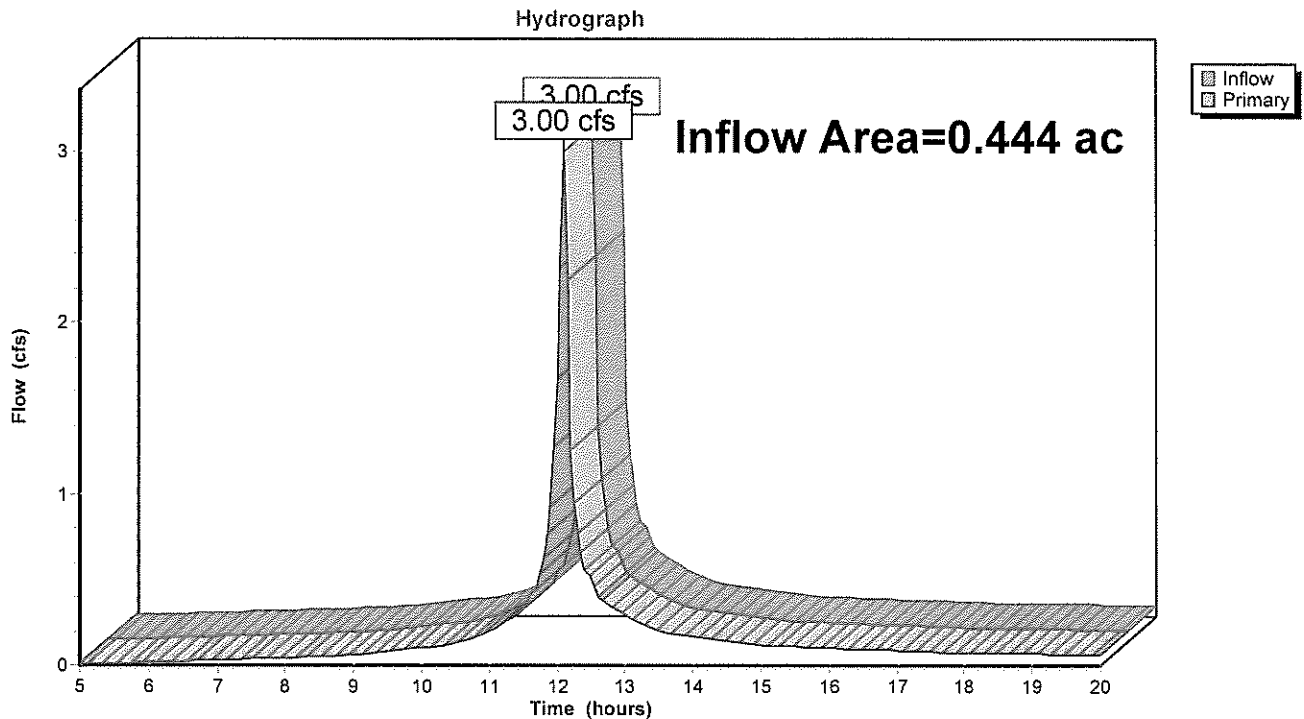
Summary for Link MS: Design Point - Millbury Street

Inflow Area = 0.444 ac, 20.50% Impervious, Inflow Depth > 5.42" for 100-Year event
Inflow = 3.00 cfs @ 12.10 hrs, Volume= 0.201 af
Primary = 3.00 cfs @ 12.10 hrs, Volume= 0.201 af, Atten= 0%, Lag= 0.0 min

Primary outflow = Inflow, Time Span= 5.00-20.00 hrs, dt= 0.05 hrs
